Manhole Inspection Summary

Manhole # S31G__022MH

Location Address: **509 W FAYETTE ST**

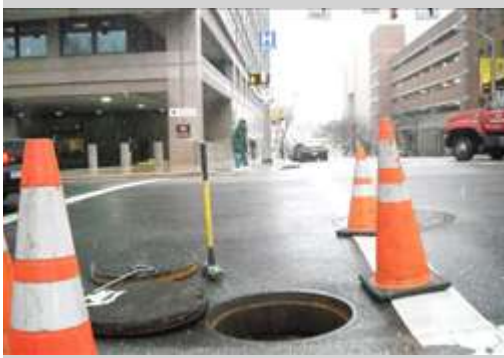
Location View

GREENE ST AND W FAYETTE ST
LOOKING AT SW CORNER

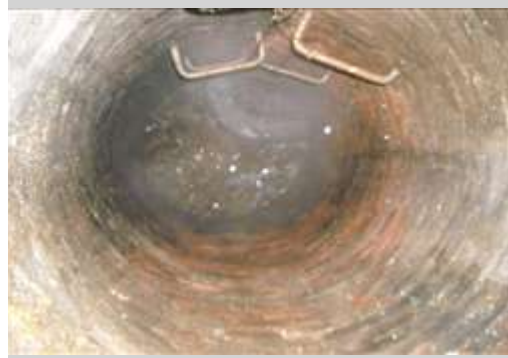
Top View

SHEETING

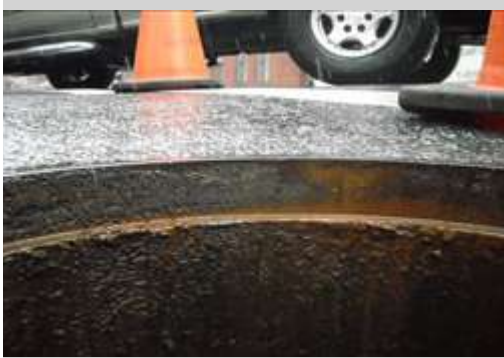
EVIDENCE OF INFILTRATION DUE TO
SHEETING FROM CROWN OF
ROADWAY

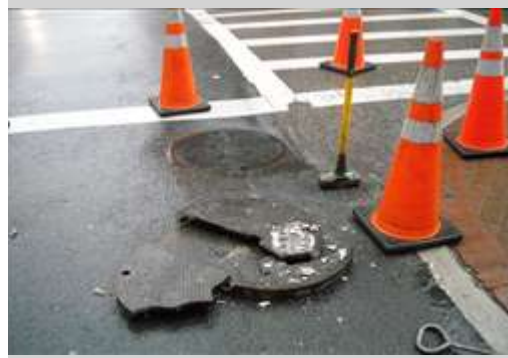
Comments **ARRIVED TO FIND 24" CRACKED AND STUCK COVER. USED 16LB MAUL TO BREAK OPEN. INSPECTION COMPLETE. REPLACED LID BY REI/DRAYCO.**

LID WAS PREVIOUSLY CRACKED -
REPLACED BY REI

BROKE AND REPLACED PREVIOUS
LID BY REI

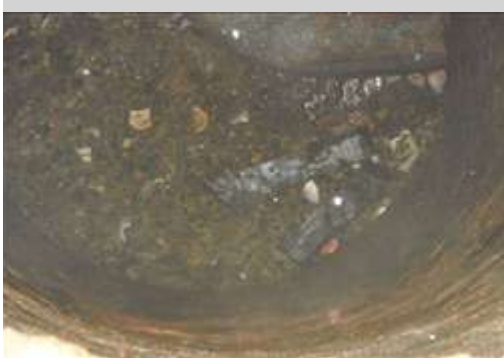
Defect 2

Condition: ☐ Sound ☐ Cracked ☐ Root Intrusion ☐ Deteriorated ☐ Leaks ☒ **Debris**

DEBRIS ON BENCH

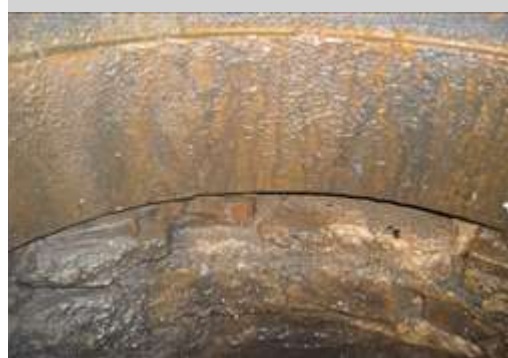
Defect 1

Condition: ☐ Sound ☐ Cracked ☐ Root Intrusion ☒ **Loose Brick** ☒ **Deteriorated**

MISSING BRICKS AND MORTAR
BELOW FRAME - LARGE GAP

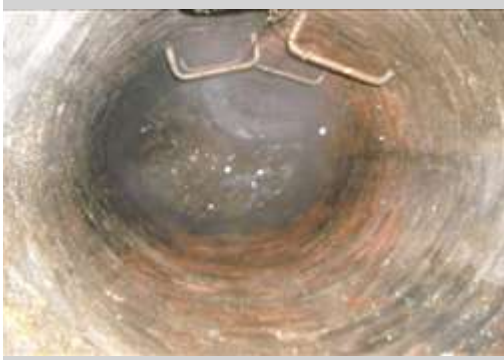
Defect 3

Steps Count: **8** Missing: **0** ☒ **Corroded**

Corroded steps

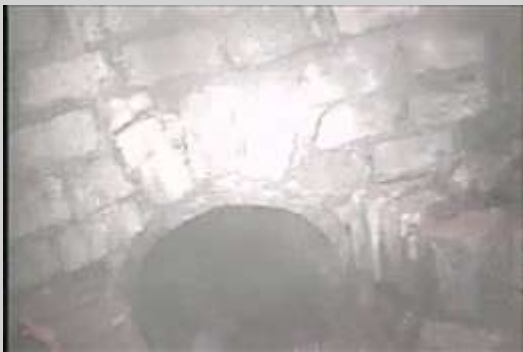
12 O'Clock Outflow

Pipe Height: **10.8** (in.) Rod and Bar (Angled)
Pipe Material: **Clay** ☐ Pipe Lined
Invert Depth: **14.17** (ft.) Flow Characteristics: **Fast**
Deposits: ☒ None ☐ Mud ☐ Sludge ☐ Debris ☐ Grease
Silt Depth: **0** (in.) Deposits Extent:
Infiltration: **None** Pipe Seal Cond: **Sound**

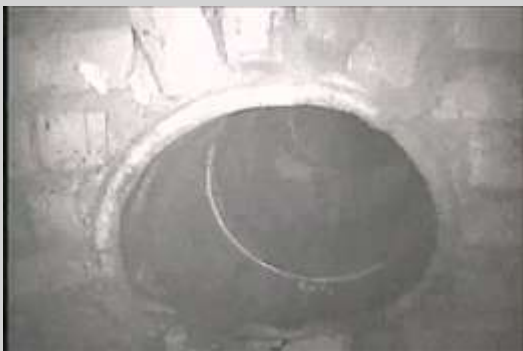
3 O'Clock Inflow

Pipe Height: **15.6** (in.) Rod and Bar (Angled)
Pipe Material: **Clay** ☐ Pipe Lined
Invert Depth: **12.99** (ft.) Flow Characteristics: **Fast**
Deposits: ☒ None ☐ Mud ☐ Sludge ☐ Debris ☐ Grease
Silt Depth: **0** (in.) Deposits Extent:
Infiltration: **None** Pipe Seal Cond: **Sound**

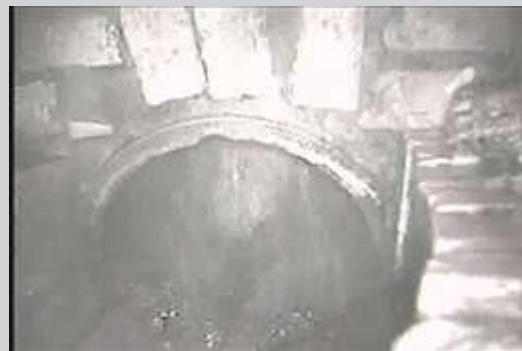
Drop In @ 3 O'Clock

Drop: **Inside** Rod and Bar
Angled: **Yes** Reading: **13.18** (ft.)
Inv Depth: **14.18** (ft.)
Drop Condition: **Open**
